# Existing Building Commissioning

## A Case Study

By Ryan Lean and Molly Dee

The Brooklyn Museum—one of the oldest and largest in the United States—experienced the challenges associated with gallery climate control firsthand, following a phased renovation. Seeking to resolve unstable temperature and relative humidity in gallery spaces, the Museum underwent existing building commissioning.

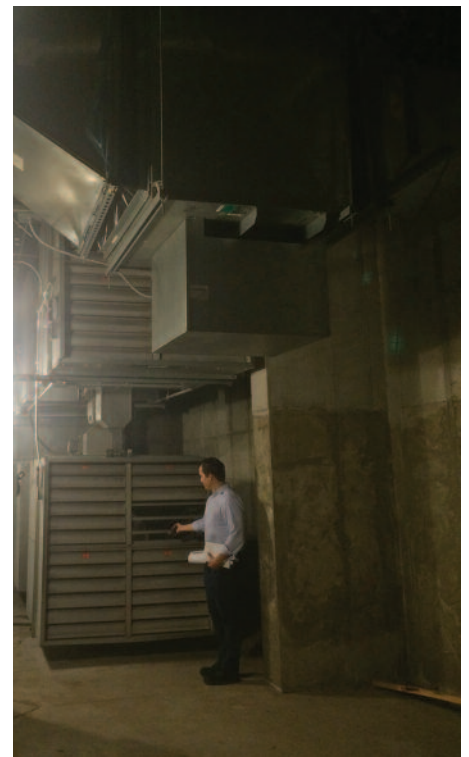
One issue discovered during this phase was a set of fatigued backdraft dampers installed on the discharge side of the variable-air-volume return fans. With the fans in operation, these partially closed dampers were impeding the free flow of air back to the air-handling units, ultimately leading to a large deficit of air on the return side of the system. This problem was identified early in the process, but the full effect of the deficient backdraft dampers on the system was not realized until later, when the testing, adjusting and balancing contractor arrived onsite. This became a central focus of the balancing effort, and provided an excellent opportunity to improve the air-distribution system.

Commissioning Engineer Philip Karnicki illustrating the change in airflow through a set of fatigued return air dampers when forced open.

The balancer took airflow readings at each fan (AHU supply and return) and its associated supply and return branch ducts. This allowed the team to confirm design airflow at the source. This was a critically important step that alerted the EBCx team of the extent to which the fatigued backdraft dampers at the return fans were negatively affecting the performance of the system.

A close look at the return-branch duct airflow readings with the backdraft dampers partially closed, when compared with the readings taken at the fan discharges with the dampers forced fully open, revealed that nearly half of the air was being lost on the return side of the system. Additionally, the duct airflow readings drew the EBCx team's attention to a partially closed fire/smoke damper in a smaller return-air branch duct. By addressing these issues, the Museum could increase the airflow in the system and further

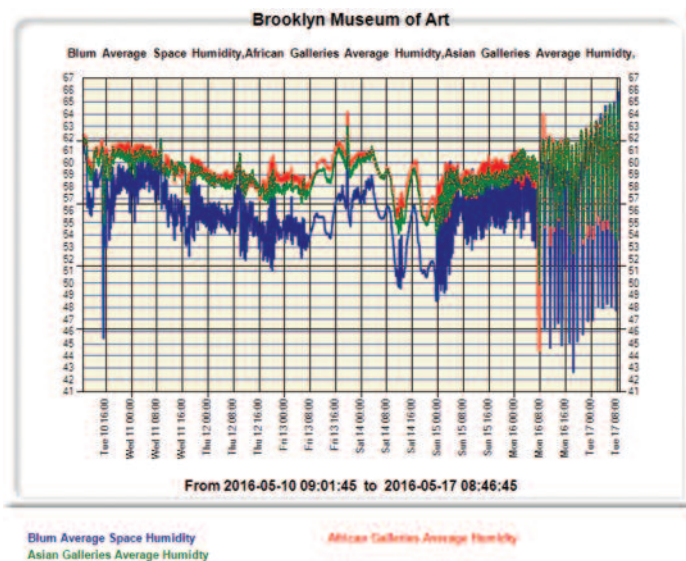
Building management system (BMS) trend of average gallery relative humidities in May of 2016 at the start of the Existing Building Commissioning (EBCx) process. Trend data revealed poorly controlled humidities well outside of the acceptable range.

To resolve this issue, the team recommended using the average RH as the humidification control point. The commissioning engineers and BMS provider made the programming change, monitored the trends of gallery temperature and humidity, and tuned the control loops until the gallery climate stabilized within the acceptable range.

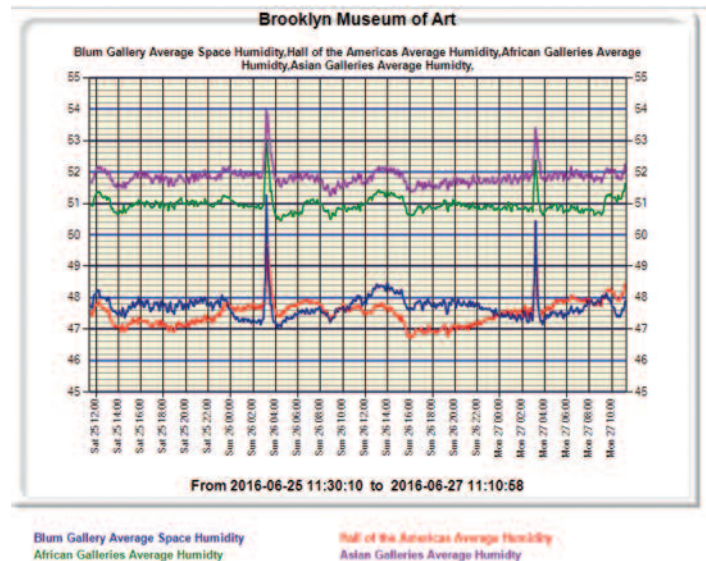
Building management system (BMS) trend of average gallery relative humidities in June of 2016 after implementation of corrective actions identified during EBCx. Trend data revealed improved control and conditions within the 45–55% RH range.
